Report No. UT-02.17

***PAVEMENT AND
SUBGRADE DISTRESS –
REMEDIAL STRATEGIES
FOR CONSTRUCTION AND
MAINTENANCE (I-15
Mileposts 200-217)***

**By: Kyle M. Rollins, Ph.D
Ryan Christie**

**Utah Department of Transportation
Research Division**

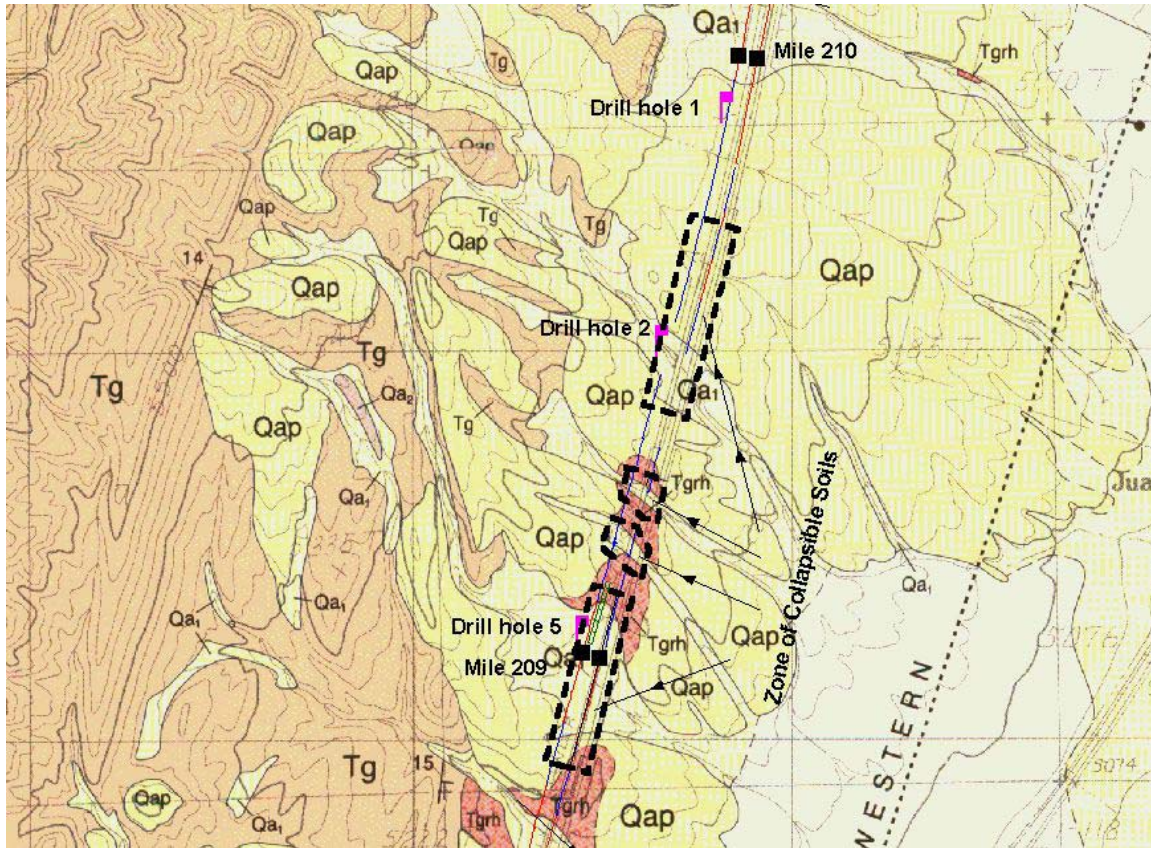
Based on the surficial geology and the borehole data, zones were identified where collapsible soils were likely the problem. Figure ES-1 provides a close-up view which shows the zones relative to the borehole locations and distress points. The combined length of the four zones is 0.735 miles. The first zone starts, for both south and northbound lanes, at mile 209.728 and ends at mile 209.412 for a length of 1670 feet. The second zone, starts at mile 209.308 and ends at mile 209.245 for a length of 332 feet. The third zone starts at mile 209.22 and ends at mile 209.153 for a length of 352 feet. The fourth zone, for both the south and northbound lanes, starts at mile 209.108 and ends at mile 208.814 for a length of 1550 feet. These boundaries will likely need to be refined during construction as more information on the exact boundaries is uncovered. The present boundaries are somewhat conservative and extend through the fan material and into the cut sections in some cases.

Figure ES-1: Map showing the four zones where collapsible soils have led to concentrated damage in the vicinity of milepost 209 and test holes 2 and 5. Lithology in the drainage basins upstream from the alluvial fans is conducive to the formation of collapsible soil.

Because the zone of collapsible soil extended to depths of up to 20 ft below the ground surface, deep dynamic compaction was recommended over excavation and replacement as a treatment method in these zones. Deep dynamic compaction has been employed with success in treating collapsible soil problems below interstate highways in New Mexico, Wyoming and Montana. This in-situ treatment method is one of the most economical soil improvement methods available (approximately \$1 to \$1.20 square foot of surface area) Recommendations for drop weight and height, energy per surface area, drop spacing and number of drops are presented in the body of the report. *After dynamic compaction every effort should be made to minimize water infiltration due to ponding at culverts and within other surface drainage features.*

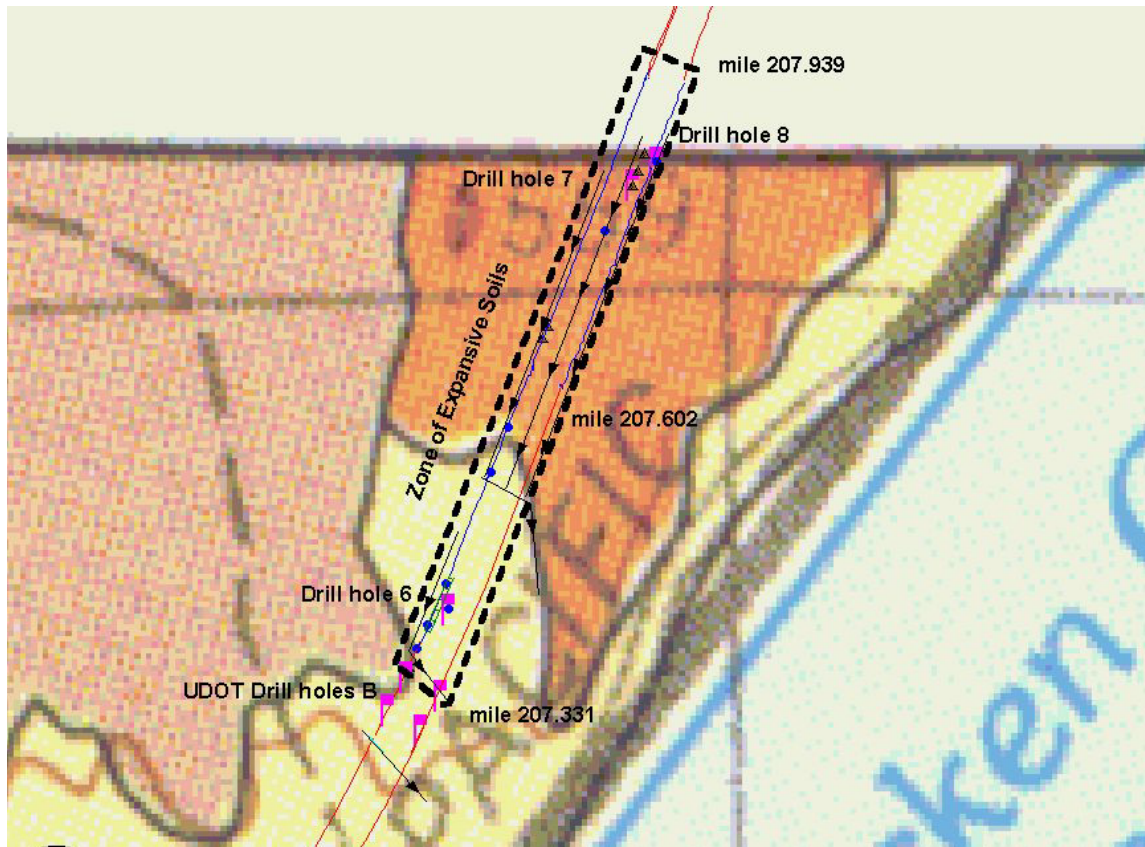
Distress related to expansive soils exists throughout the study area, but significant damage concentrations are located in a cut section between mileposts 208 and 207 along I-15. This area is long enough to propose treatments for the area, in order to improve ride quality throughout the cut section. Other areas are isolated and are generally too minor to be considered for treatment proposals. The map in Figure ES-2 shows the expansive soil zone which is recommended for treatment along I-15 and also includes the distress features and drainage paths throughout the cut section. The length of the treatment zone is 3209 feet in the Southbound lane (0.608 miles, Milepost 207.939 - 207.331) and 1779 ft in the Northbound lane (0.337 miles, Milepost 207.939 - 207.602).

Figure ES-2: Expansive soil zone proposed for treatment and the distress features throughout the cut section between mileposts 208 and 207 along I-15, Juab County, Utah.

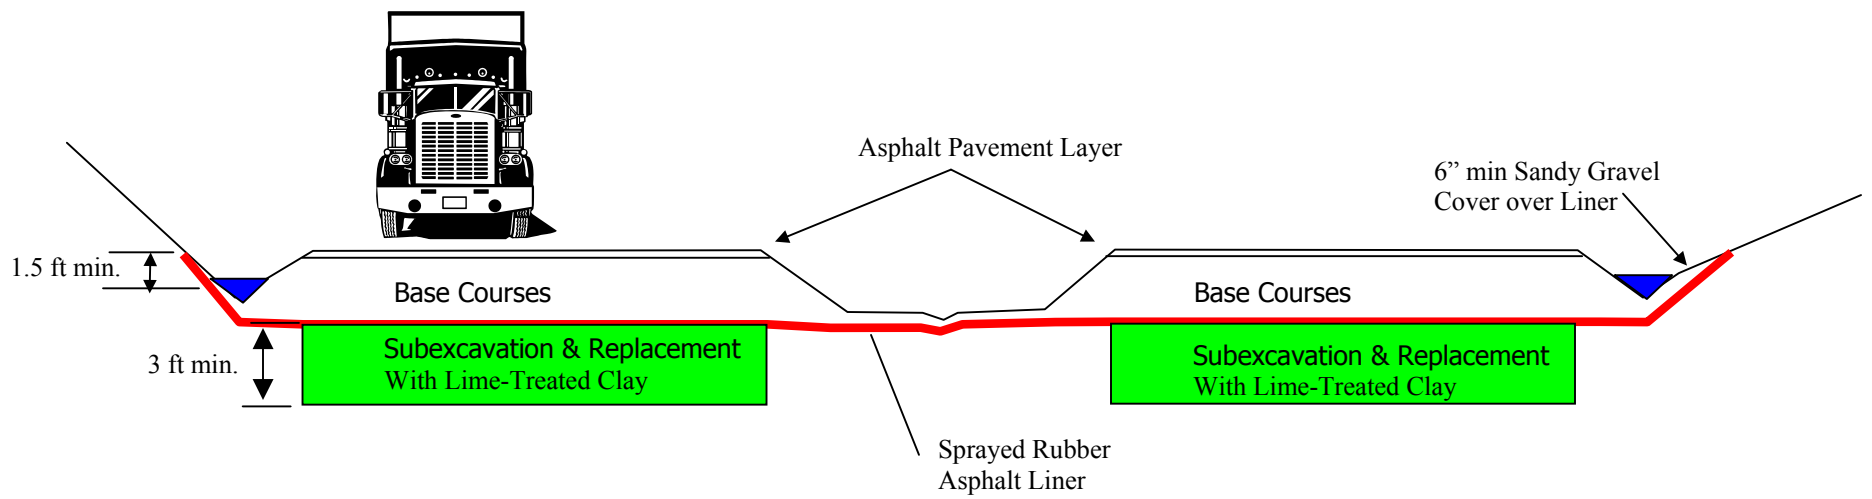
Figure ES 3: Schematic drawing of typical cross-section in expansive soils treatment zone.

A number of options for treating expansive soils are available; however, no single method has proven foolproof in practice. This study recommends a combination of methods as illustrated in Figure ES-3 to improve the odds of success. First, we recommend excavation of three feet of the expansive material and recompaction with the same soil treated with 5% lime. Laboratory tests indicate that lime treatment will significantly reduce the plasticity of the clay (from PI of 70 in untreated to 17 in treated soil) and increase the CBR (from about 5 in untreated to 50 in treated soil). Second, we recommend a continuous rubber asphalt layer which would extend under the drainage ditches on either side of the interstate. This layer would prevent infiltration of water into the subgrade which has occurred with the current surface drainage system. This impervious layer would need to be covered with a six inch layer of soil to protect it from damage. Finally, we recommend that the base courses be placed above the liner and that an asphalt wearing surface be used rather than concrete to minimize the potential for cracking.

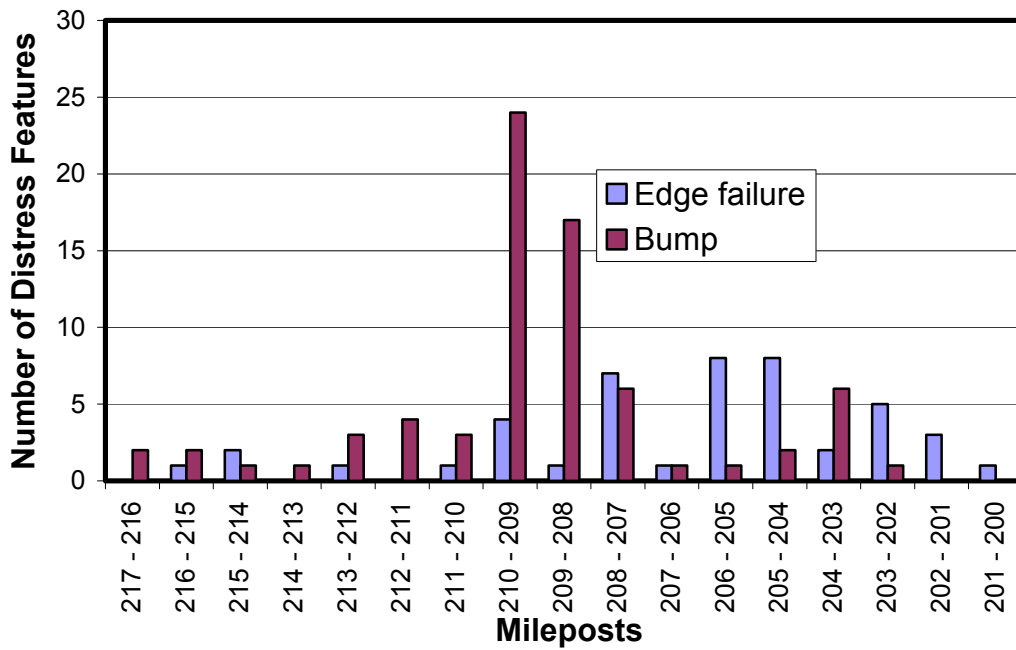
The number of edge failures and bumps within each mile of the study area is shown in Figure 1. The percentage of the total bumps, cracks and edge failures between each mile post is also shown in Figure 2. Over 49% of the 119 points occur between mileposts 210 and 207. Within these three miles there are 47 bumps and 12 edge failures/cracks. The majority of the bumps are between mileposts 217 and 207 and the majority of the edge failures/cracks are between mileposts 208 and 200.

Figure 1: Points of damage including bumps and edge failures (includes cracks) vs. Mileposts; I-15 between Mileposts 217 and 200, Juab County, Utah, 2000.

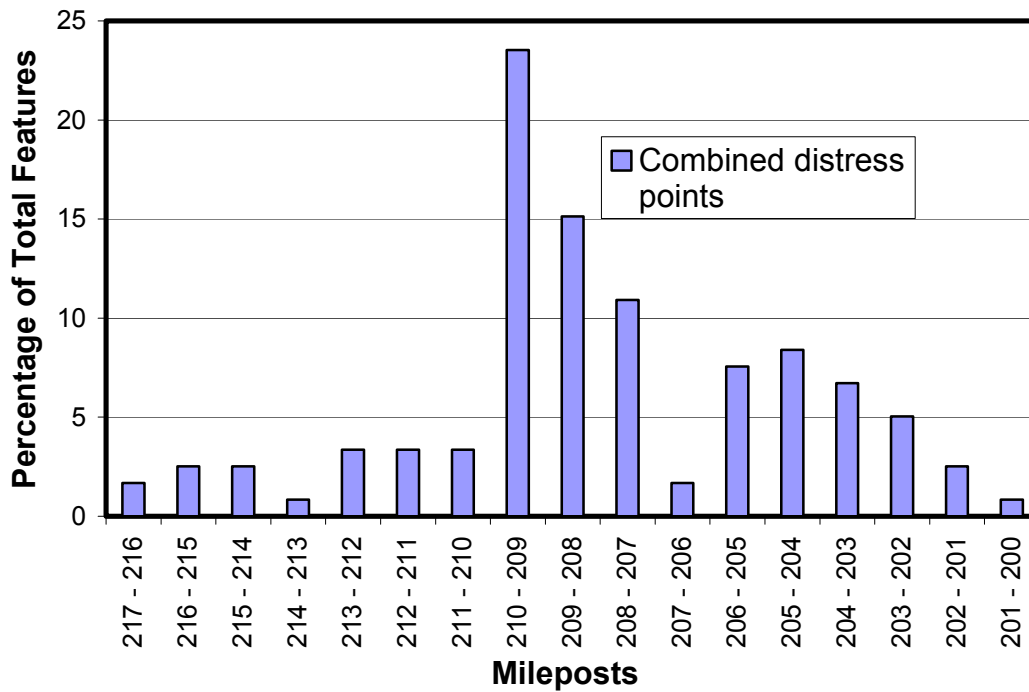
Figure 2: Combined percentage of distress points vs. Mileposts in between mileposts 217 and 200, I-15, Juab County, Utah, 2000.

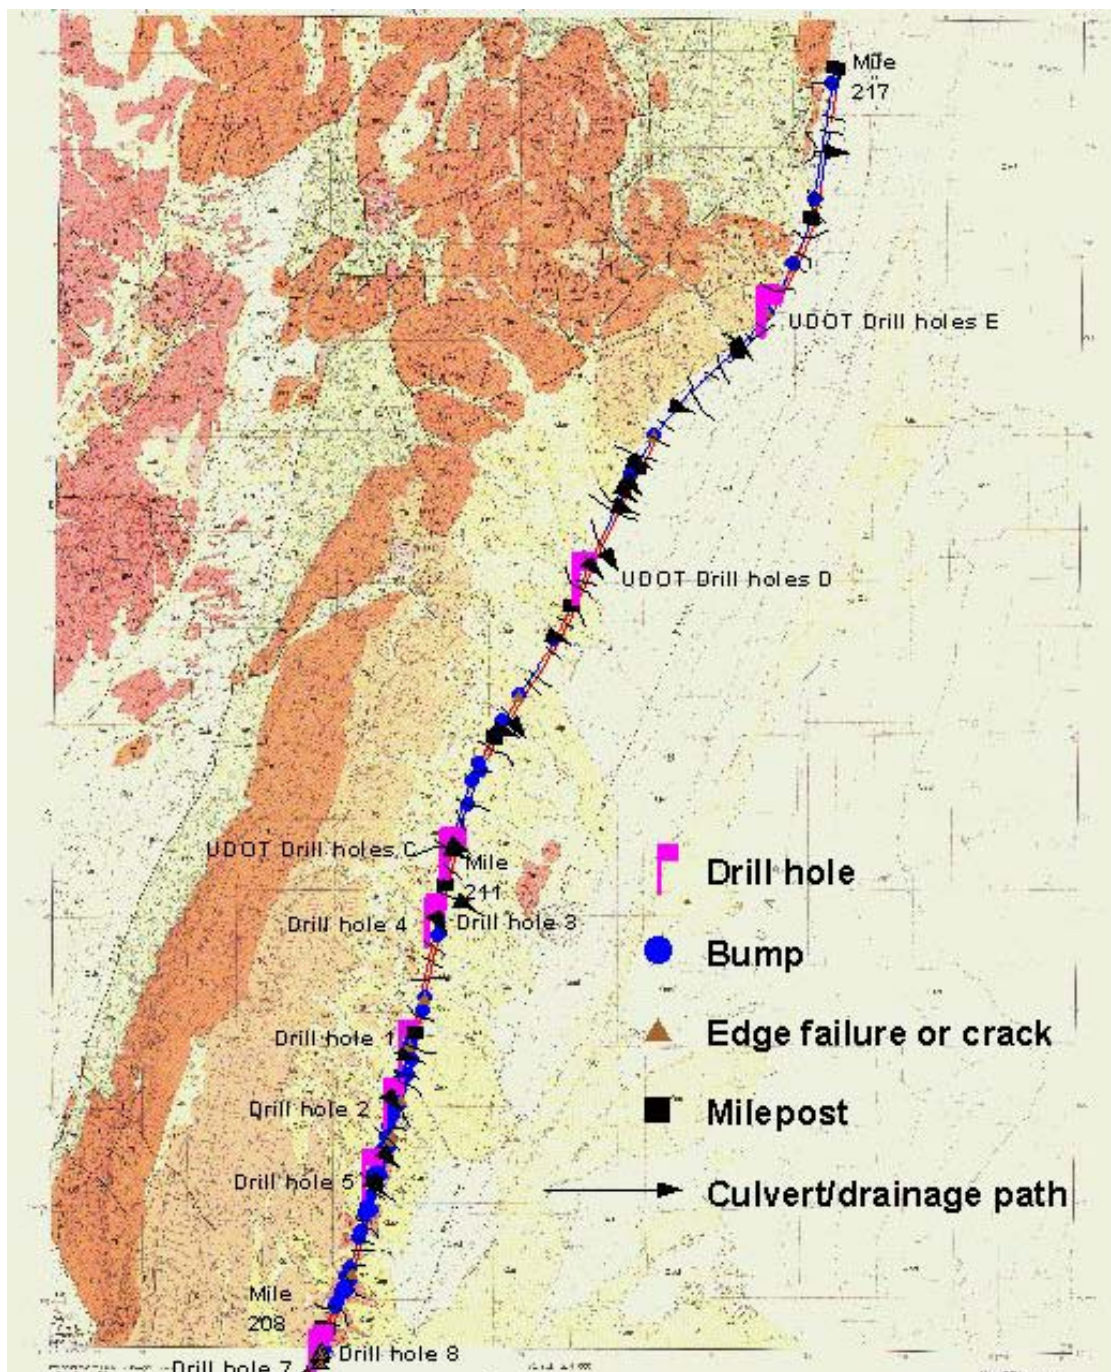
Figure 4: Map of Juab Quadrangle showing distress features, Drill Holes, mileposts, and where drainage paths flow under the freeway through culverts along I-15, UT.

Distress features that relate to expansive soils are found within two main cut sections. One cut section is near Drill Hole 1 and milepost 210 (Fig. 4). The other cut section is between Drill Holes 6 and 8, which is between mileposts 208 and 207 (Fig. 5). Expansive soils appear to be associated with units Trgh, Tvg and Tg. Distress features within these units account for 26% of the distress features overall. Out of the 14 distress points located in the Tvg unit, which has a high potential for expansive materials, 13 of them are within the second cut section between mileposts 208 and 207. A bar graph is shown in Figure 16 which indicates the percentage of distress features, which correlate with the collapsible soils and the expansive soil units.

A total of 20 or 16.8 % of the distress features fall within 100 feet of a cut/fill transition zone and therefore could be related to soil density contrasts between the cut section and the fill section. A total of 18 or 26.9 % of the distress features in the Juab Quadrangle (Fig. 4) occur within 100 feet of a cut/fill transition zone. Only 2 or 6.9 % of the distress features in the Skinner Peaks Quadrangle (Fig. 5) occur within 100 feet of a cut/fill transition zone. The Mills Quadrangle (Fig. 6) has no distress features that occur within 100 feet of a cut/fill transition zone.

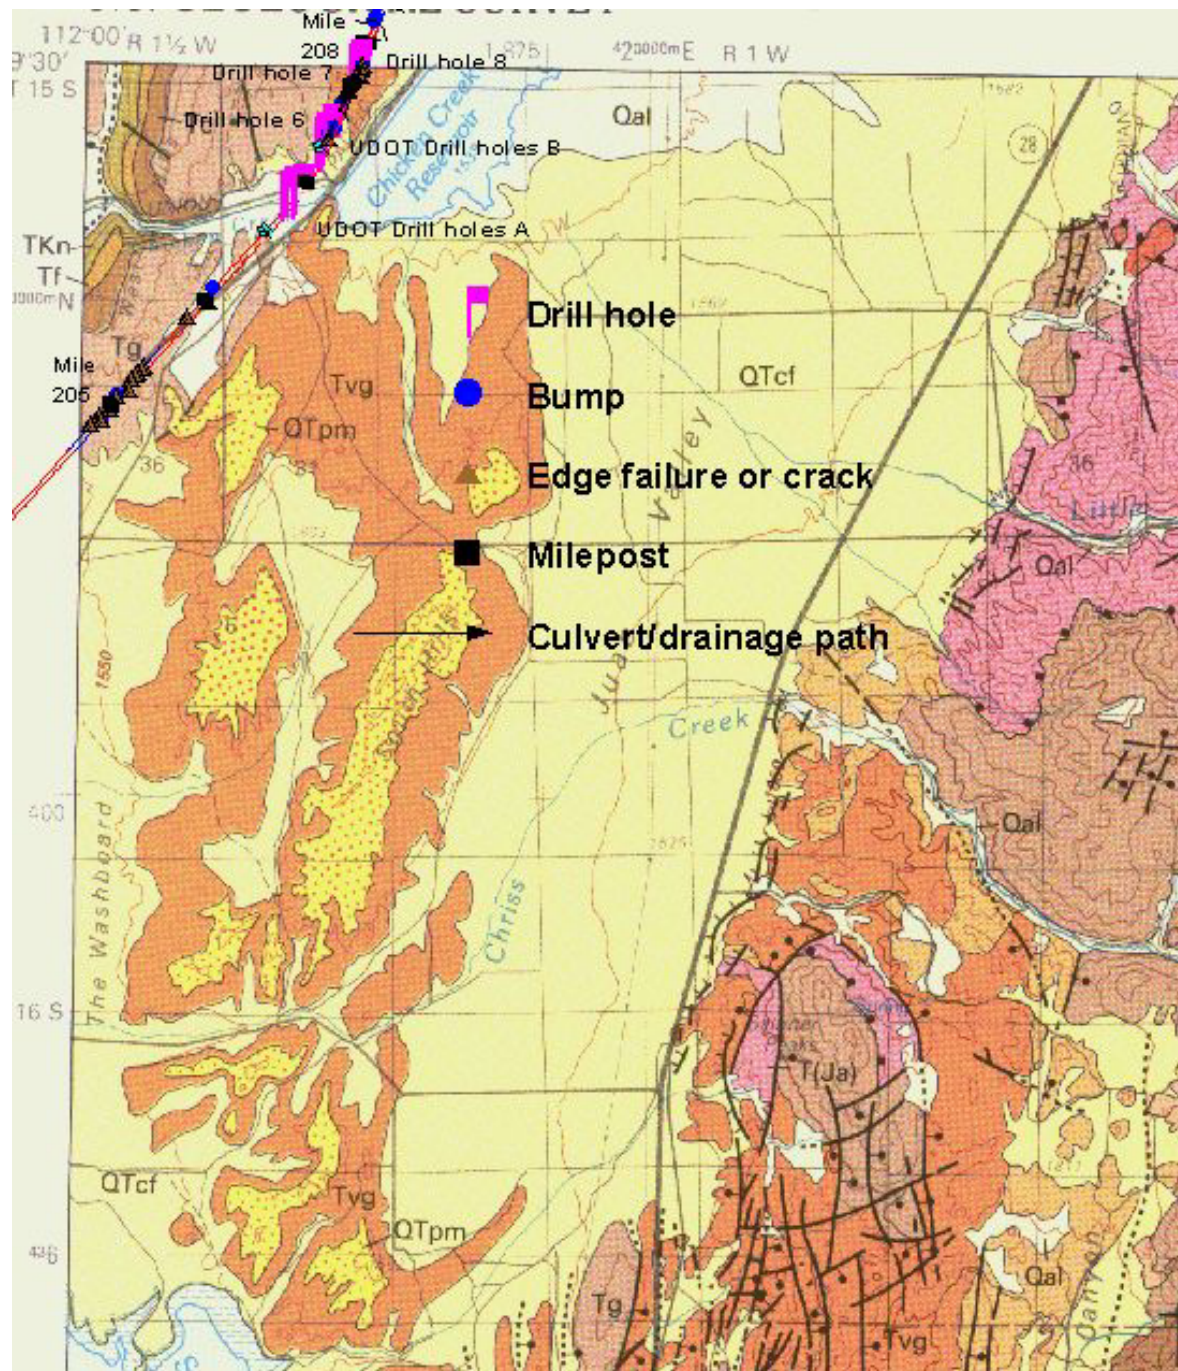
Figure 5: Map of Skinner Peaks area showing distress features, Drill Holes, mileposts, and where drainage paths flow under the freeway through culverts along I-15, UT.

UDOT Drill Holes A are located about 0.1 miles south of milepost 206. These holes are located within Qal materials on the surficial geologic map as shown in Figure 5. The boring logs for the four holes are presented in Figure 77. The soil profile typically consists of 1 foot of sandy silt which is underlain by thick layers of soft silty clay to depth of about 40 feet. The groundwater was located at 5 to 7 feet below the existing ground surface at the time of drilling. These materials typically have plasticity indices between 27 and 30. This would indicate a moderate potential for expansion. No significant distress features were observed in the immediate vicinity of these test holes.

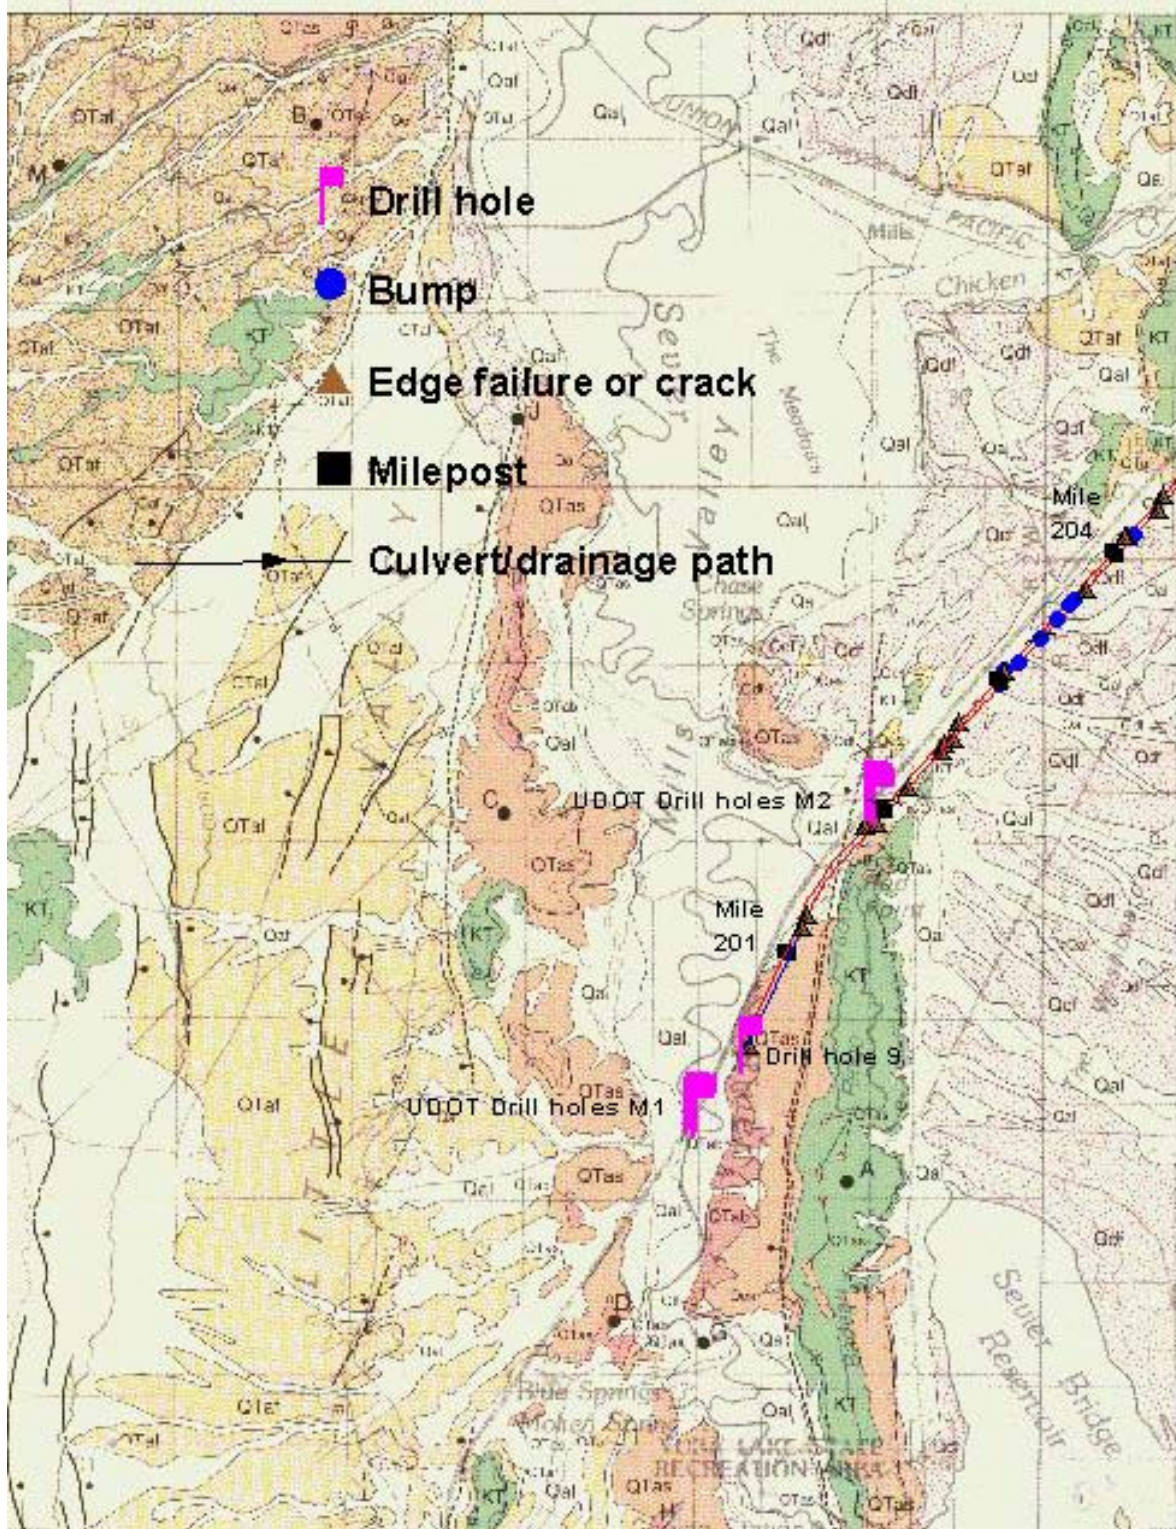
Figure 6: Map of Mills area showing distress features, Drill Holes, mileposts, and where drainage paths flow under the freeway through culverts along I-15, UT.

UDOT Drill Holes M2 are located near milepost 202. These four holes are located within Qal materials based on the surficial map as shown in Figure 6. However, they are also quite close to the boundaries of a QTas zone. The boring logs for the four holes at this location are shown in Figure 78. The soil profile consists of medium to hard silty clay and clayey silts to about 80 feet below the ground. The groundwater is at 16 to 20 feet below the ground surface is quite similar to that for Drill Holes A. The plasticity index ranges from 18 to 30, which suggest that they may present minor expansion problems. In comparison with Drill Holes A the soil classification is similar; however, the water table is deeper, the soils are stiffer, and they exhibit somewhat lower plasticity.

Drill Hole 9 is located about 0.45 miles south of milepost 201 on the east side of the northbound lanes within a shallow cut section as shown in Fig. 6. The geologic units that correlate with Drill Hole 9 are QTab and QTas. Drill Hole 9 was drilled near the borderline between the two units (see Fig. 6). The boring log for the hole is presented in Figure 78. The soil profile generally consists of a layer of sandy silt about 2 feet thick which is underlain by an 8 feet thick layer of relatively plastic clay. Below 11.5 feet this clay layer is in turn underlain by layers of silty sand and gravel. The water table is located at a depth of about 15 feet. The Atterberg limits and consolidation tests on samples from Drill Hole 9 indicate that the clays may be moderately expansive. There are two edge failures next to Drill Hole 9, which could be related to an inadequate pavement section, pumping of the silts immediately below the concrete pavement or to expansion of the subsurface soils. Figures 80 and 81 are pictures of the area and distress features around Drill Hole 9. The edge of the pavement is broken into several small pieces near Drill Hole 9 and the outer northbound lane has received a surface overlay.

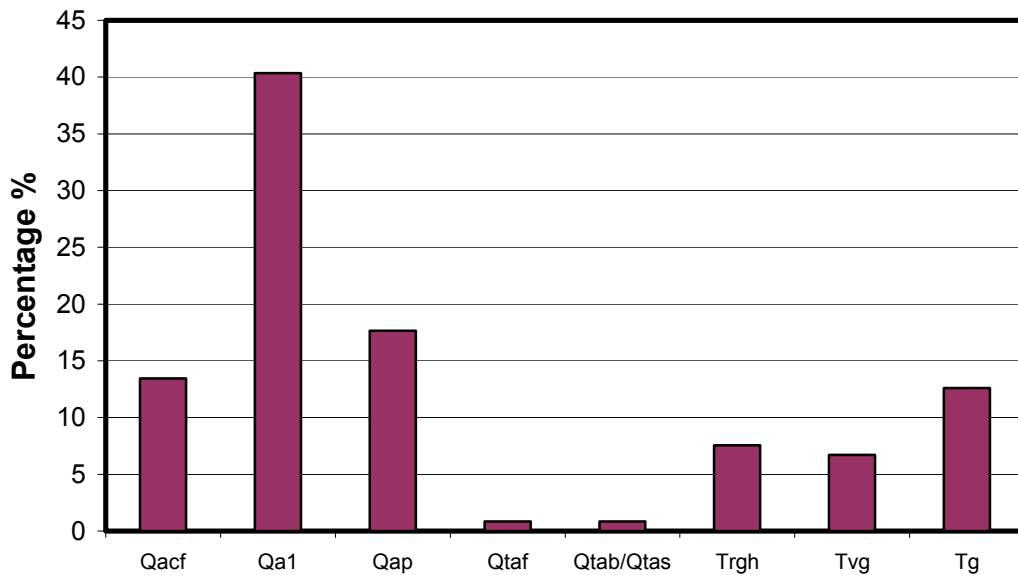
Figure 15: The percentage of total distress features within various surficial geologic units between mileposts 217 and 200. The percentage is based on 120 distress features.

The greatest percentage of distress features, nearly 40 %, fall within zones mapped as Qa1 materials. Thereafter, the percentage of distress points in various geologic units then decreases following the order of Qap, Qacf, Tg, Trgh, Tvlg, Qtaf, and Qtab/Qtas. Qtab/Qtas units are grouped together, because there is a distress feature that is on the borderline between both geologic units. Figures 7 through 10 illustrate the percentages of bump features corresponding to the various geologic units in each of the map boundary and for the entire study area combined. Figures 11 through 14 present plots showing the percentage of crack and edge failure features associated with various geologic units for each map and the entire study area combined. Figure 15 is a graph of the percentage of total distress features which are associated with each geologic unit for the entire project area.

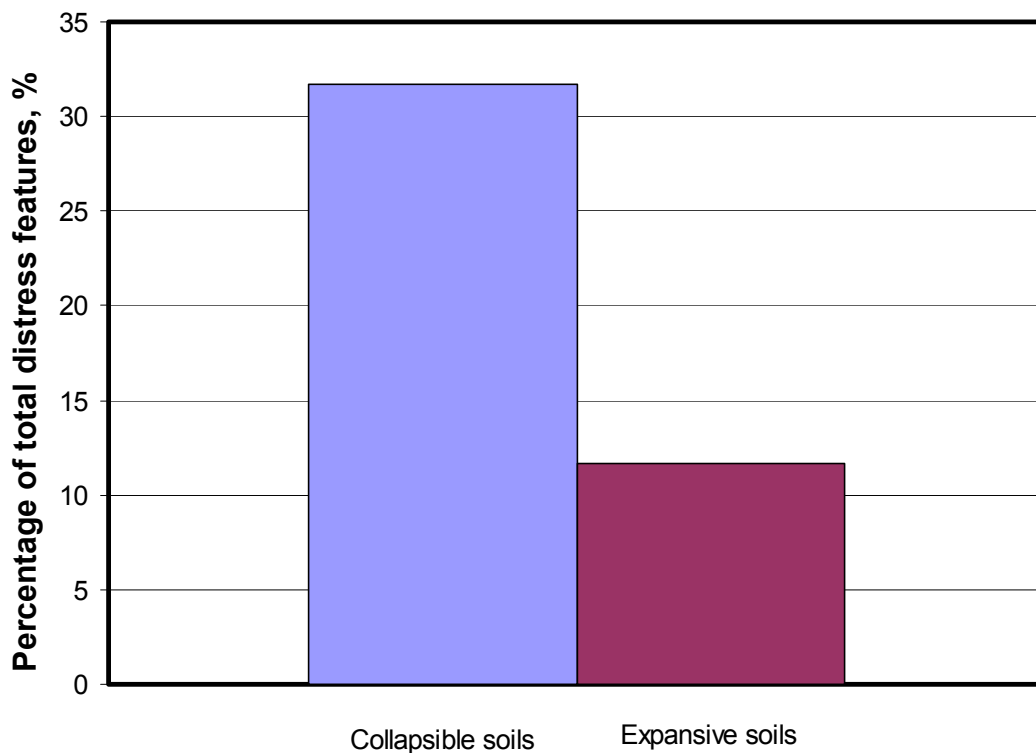
Figure 16: Percentage of distress features between mileposts 217 and 200 that are related to either a collapsible soil between mileposts 208 and 210 or an expansive soil between mileposts 207 and 208.

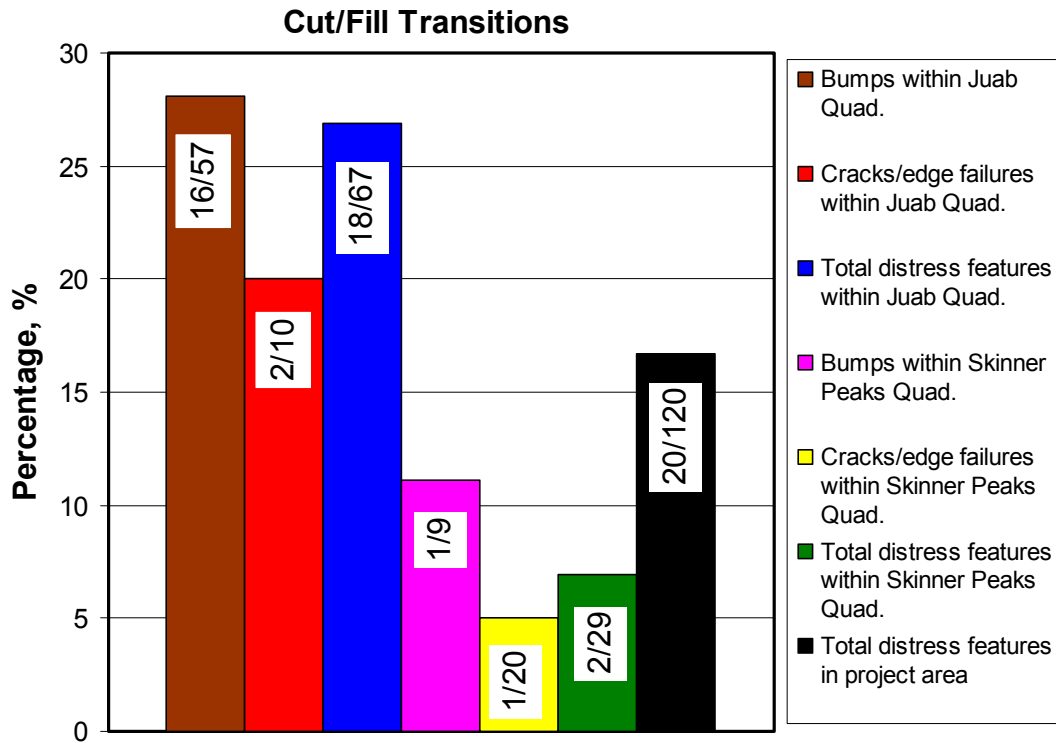
Figure 17: Percentage of bumps, edge failures, and distress features that are within 100 feet of a cut/fill transition zone for Juab Quadrangle, Skinner Peaks Quadrangle, and the entire study area between mileposts 217 and 200.

The bar graphs in Figure 17 show the percentage of bumps, edge failures, and the total number of distress features within 100 feet of a cut/fill transition zone as a percentage of the total number of bumps, edge failures, and distress features for the Juab Quadrangle, Skinner Peaks Quadrangle, and the entire study area between mileposts 217 and 200. Figure 18 represents the percentage of bumps or edge failures that occur in either a cut or fill section along I-15 between mileposts 217 and 200. Although the majority of the distress features (57%) are in cut sections, a significant percentage (43%) still occur in fill sections. Therefore, the distress does not appear to be simply a matter of poor fill construction. Our analysis also indicates that the potential for distress does not appear to be correlated with the height of the fill. In fact, in areas where the fill is relatively high, the pavement performance has been relatively good.

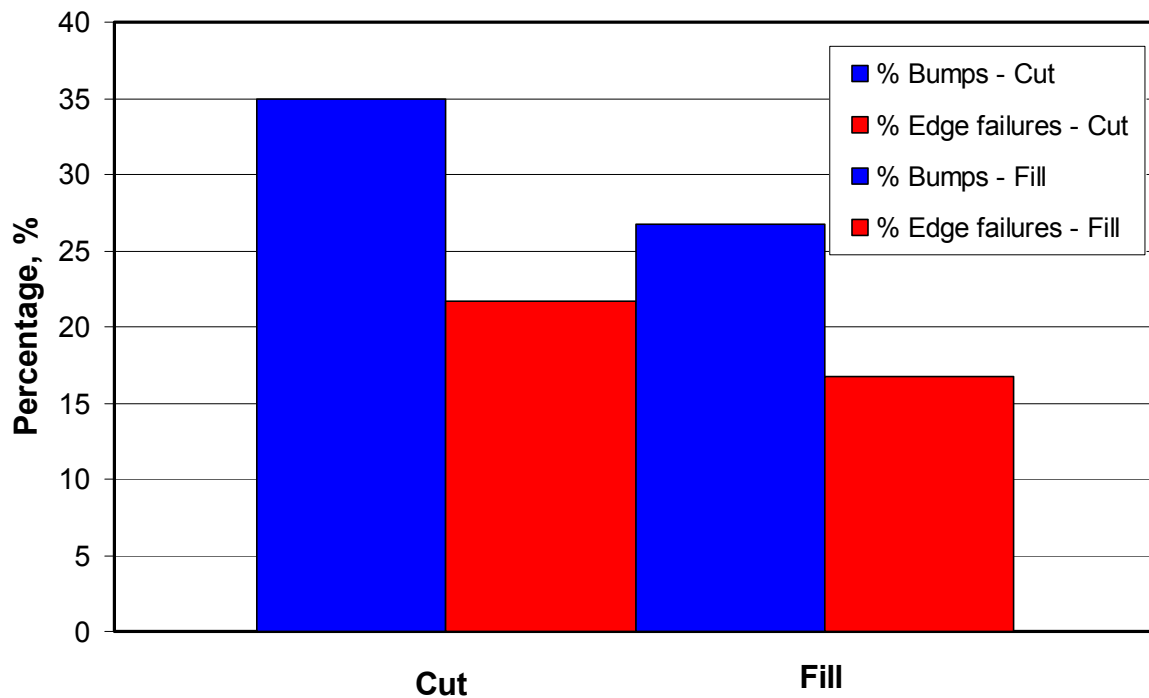
Figure 18: Percentage of total bumps or edge failures within a cut and fill section between mileposts 217 and 200 along I-15, Juab County, Utah.

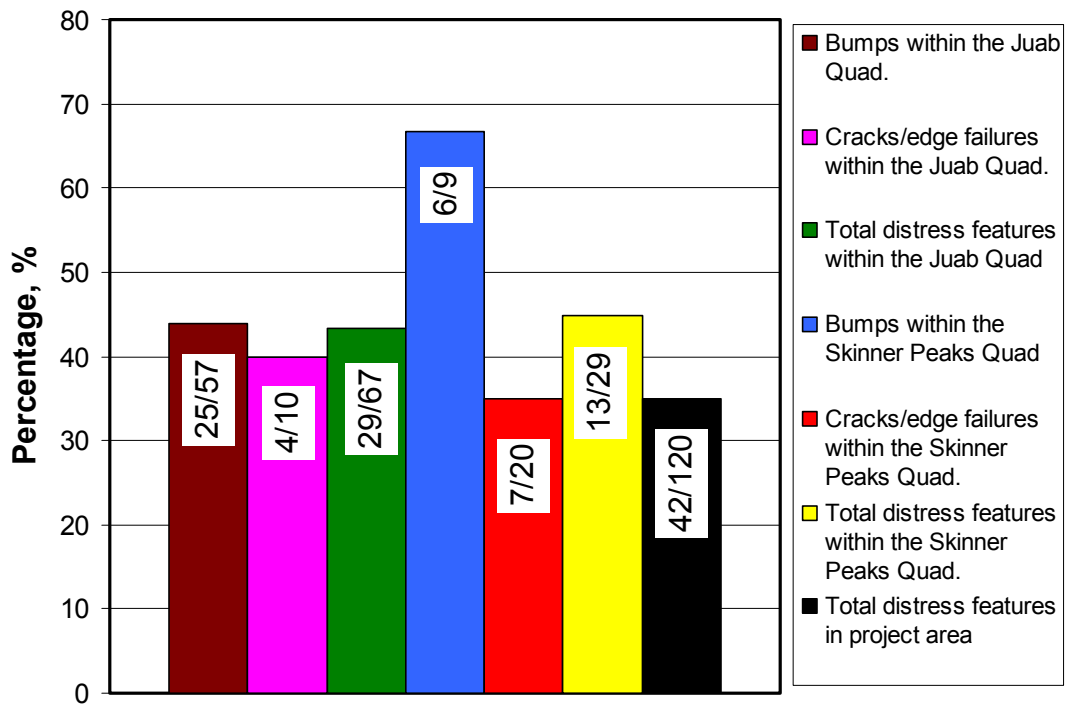
A total of 42 (35.3 %) distress features fall within 100 feet of a culvert or drainage path. Drainage problems can include inadequate compaction over the culvert and the expansion or collapse of soils from excess water permeating into the subsurface materials. 29 or 43.3 % of the distress features in the Juab Quadrangle (Fig. 4) occur within 100 feet of a culvert or drainage path. 13 (44.8 %) of the distress features in the Skinner Peaks Quadrangle (Fig. 5) occur within 100 feet of a culvert or drainage path. The Mills Quadrangle (Fig. 6) has no distress features within 100 feet of a culvert or a drainage path. The bar graphs in Figure 19 show the percentage of bumps, edge failures, and the total amount of distress features within 100 feet of a culvert or a drainage path as a percentage of the total number of bumps, edge failures, and distress features for the Juab Quadrangle, Skinner Peaks Quadrangle, and the entire study area between mileposts 217 and 200.

Figure 19: Percentage of bumps, edge failures, and distress features that are within 100 feet of a culvert or a drainage path for the entire study area between mileposts 217 and 200.

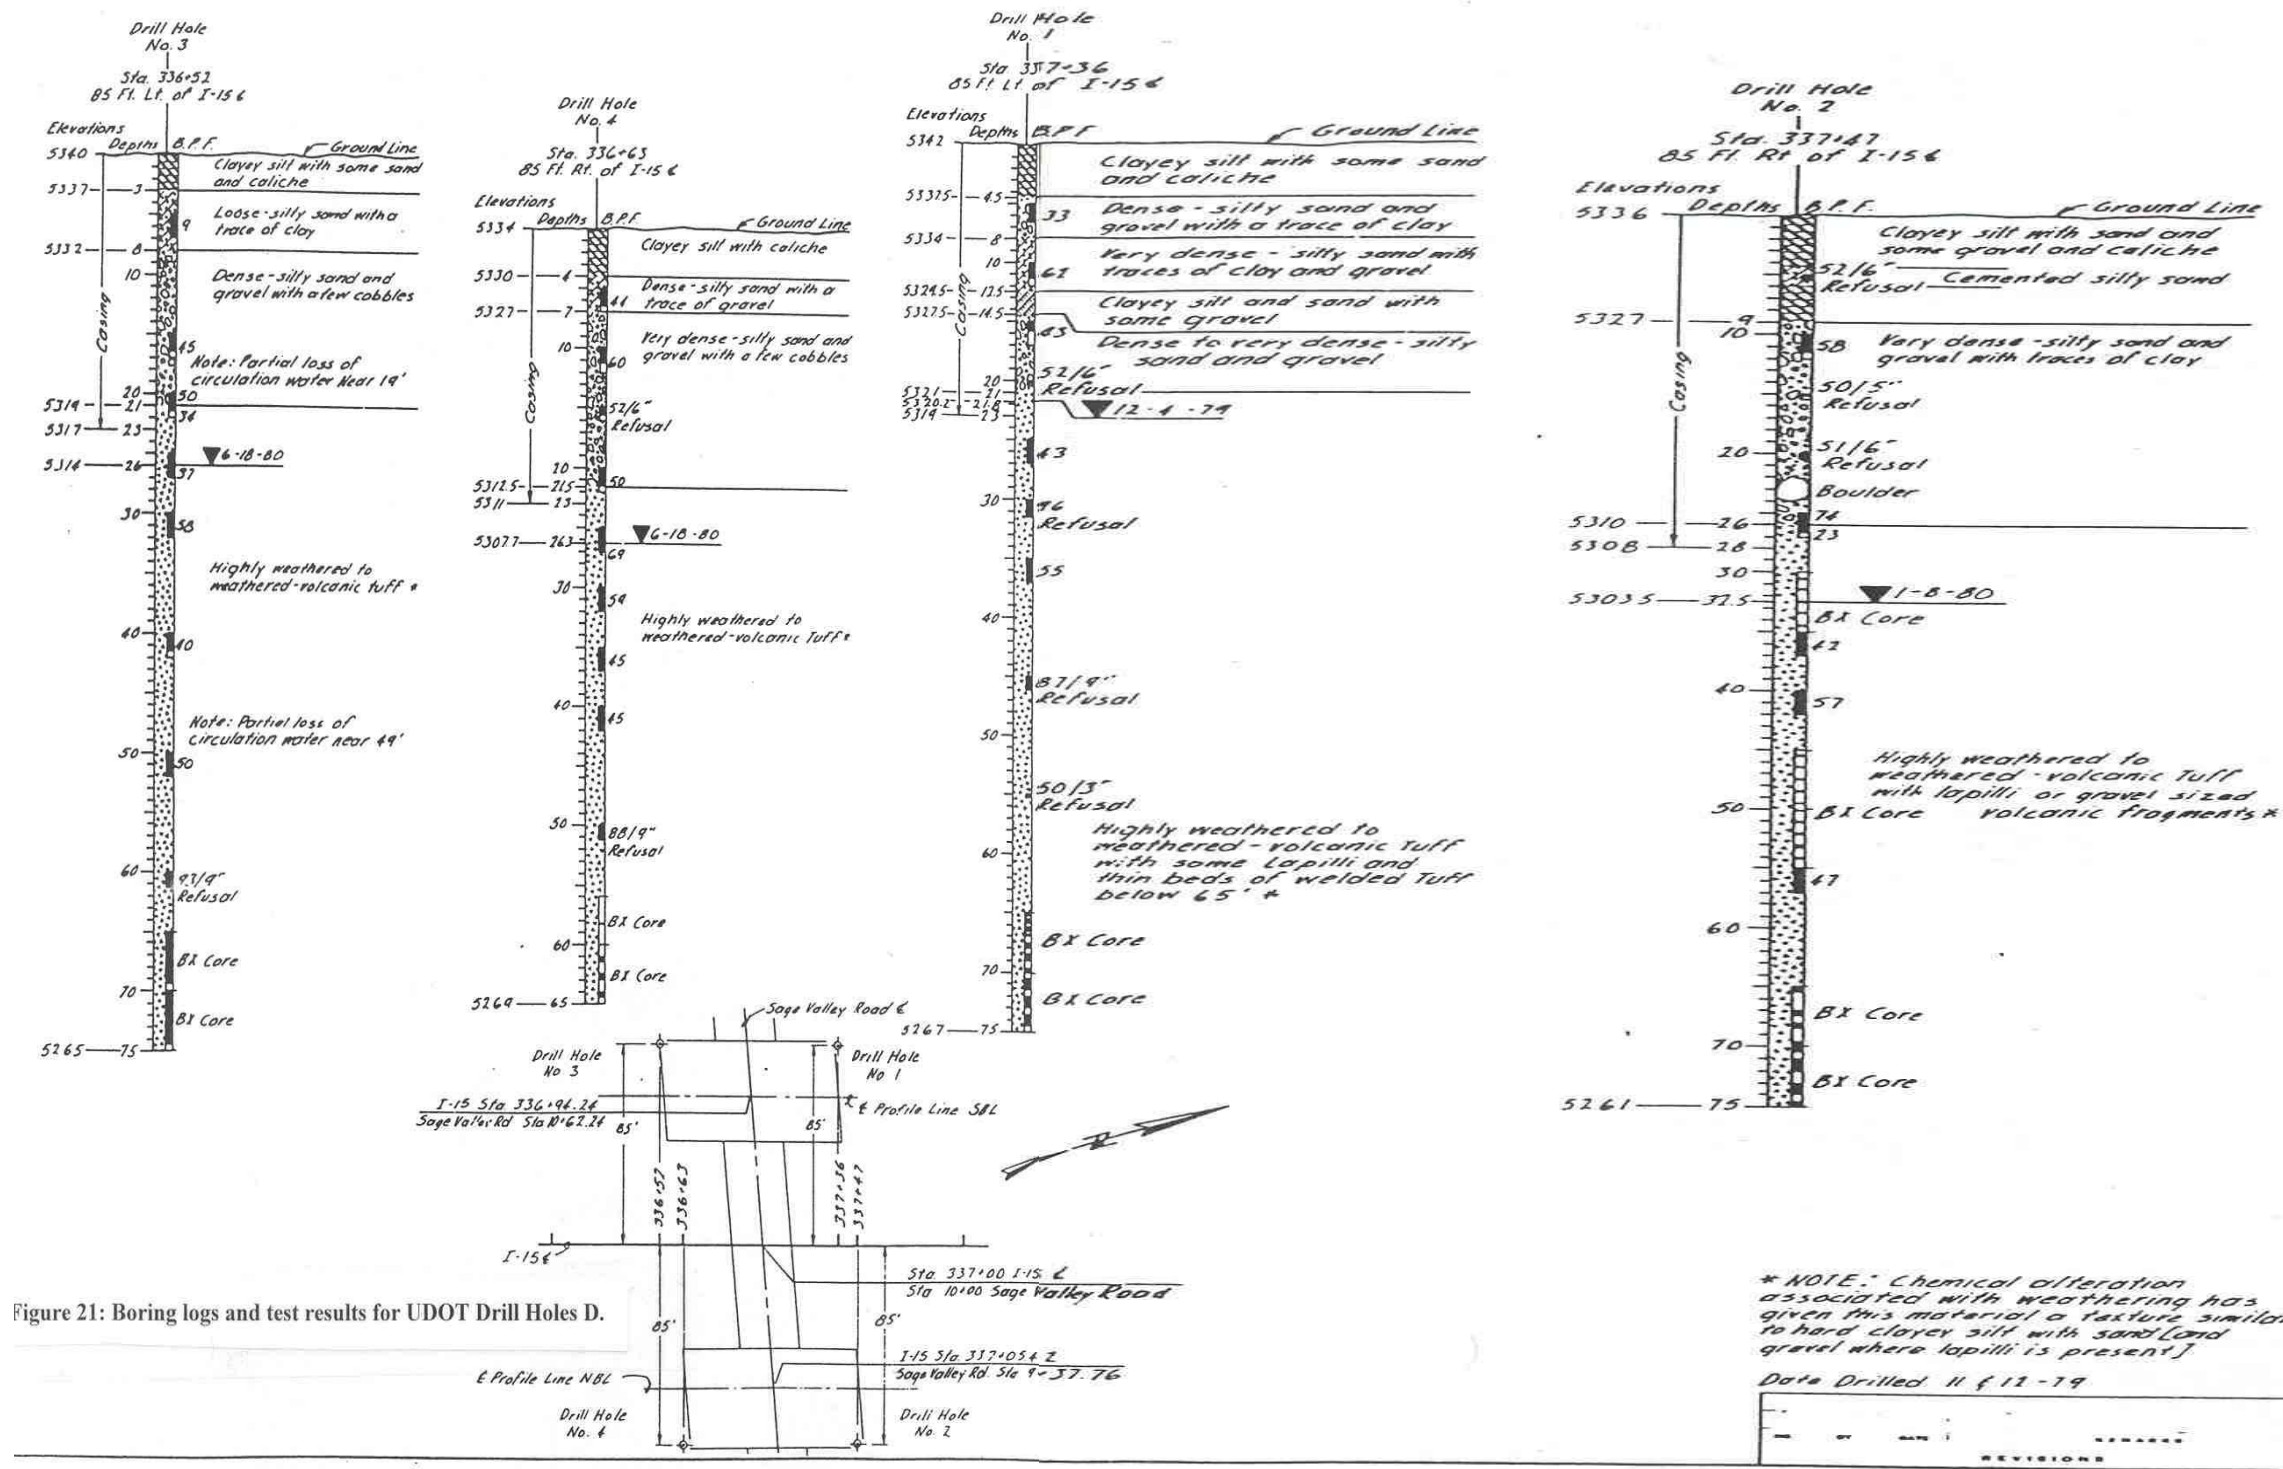
Figure 21: Boring logs and test results for UDOT Drill Holes D.

These four holes were drilled for the overpass structure F-433 over the Sage Valley road, near the northern end of the study area about 0.2 miles north of milepost 213. The boring logs for the four holes are shown in Figure 21.

No significant pavement distress features were noted in this region. These holes are drilled in the Qacf geologic unit. The boring log indicates that the soil profile generally consists of a clayey silt layer, 3 to 5 ft thick underlain by a silty sand layer, 3 to 5 ft thick, which in turn underlain by a dense silty sandy gravel layer which extends to a depth of 20 to 26 feet below the ground surface. These alluvial deposits are then underlain by a highly weathered to weathered volcanic tuff which extends to a depth of 75 feet below the ground surface. The water table is typically located a few feet below the rock-soil interface.

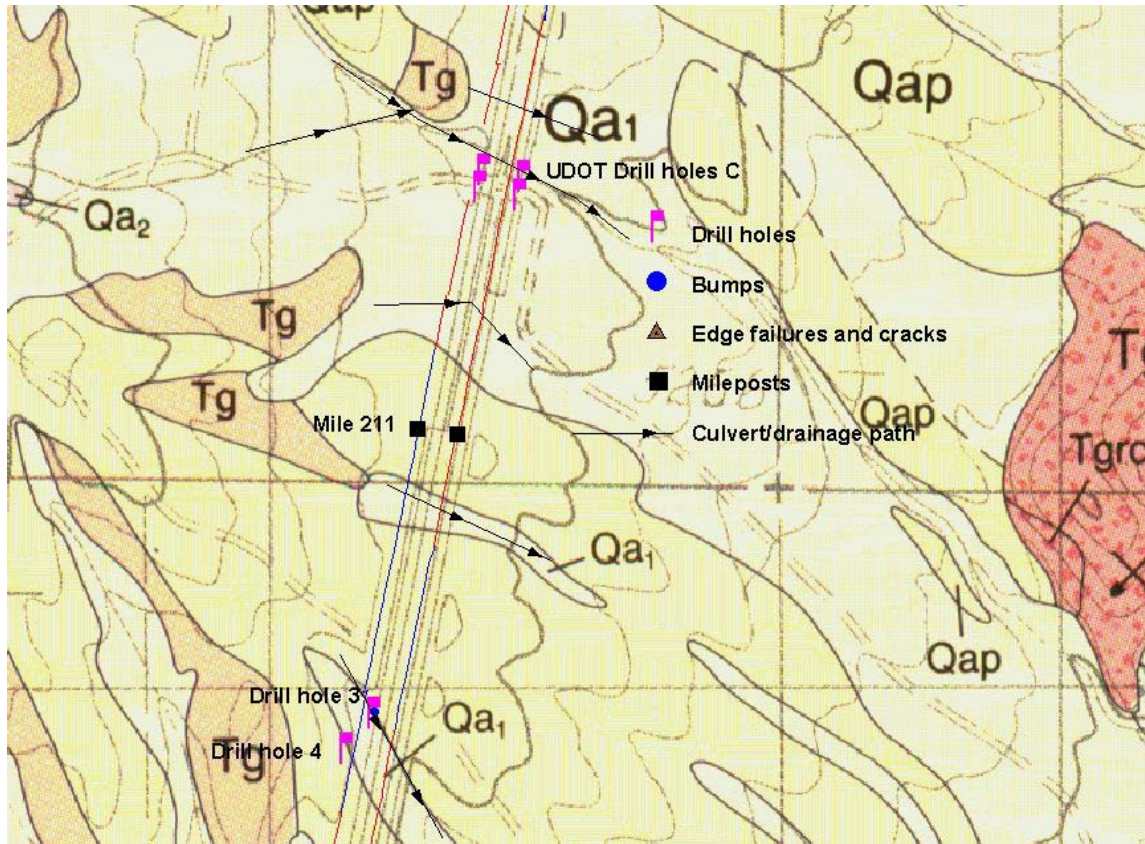
Drill Holes 3 and 4 were drilled as companion holes with Drill Hole 4 being about 100 feet south of Drill Hole 3. Drill Holes 3 and 4 are located about 1000 ft south of Milepost 211 along I-15. UDOT Drill holes C were located about 1000 ft north of Milepost 211 as shown in Figure 22. There are no distress features near either Drill Hole 3, 4 or UDOT Drill holes C. Boring logs for Drill Holes 3 and 4 are presented in Figures 23 and 24 while logs for UDOT Drill Holes C are shown in Figure 25. All of these holes are located in alluvial fan materials with geologic units defined as Qa1 or Qap. Drill Hole 3 is located in the fill section between the southbound and

northbound lanes of traffic. This hole was drilled to a depth of 15.5 feet through fill material, stream alluvium, and weathered shale/mudstone. Drill Holes 3 and 4 are located within geologic units Qa1 and Qap. To the west of Drill Hole 3 there is a cut section and to the east of Drill Hole 3 along the northbound lane there is a cut/fill transition zone. Drill Hole 4 is located about 100 ft south of Drill Hole 3 and about 20 feet away from the west side of the southbound lane of I-15 within a cut section. All the test holes are located near culverts or drainage channels.

Figure 22: Drill Holes 3, 4 and UDOT Drill Holes C near milepost 211, I-15 Juab County, UT. Cuts are in blue and fills are in red.

Drill Holes 3 and 4 encountered sandy silt and silty sand layers from the alluvial fans which could be collapsible, but the layers are relatively thin and no evidence of collapse features were observed near the drainages. In fact, these alluvial soils and the fill materials above them generally have high SPT blowcounts and are relatively dense. These alluvial soils are underlain by high plasticity clays derived from weathering of the underlying claystone and volcanic tuff. These clays were encountered at a depth of 9.5 feet in Drill Hole 3, at 3.5 feet in Drill hole 4 and at 13 to 17 ft in the UDOT Drill Hole C location. These clays are likely expansive based on their high plasticity but again there does not appear to be any major pavement distress in this area. Apparently the relatively low permeability of the dense overlying material was sufficient to prevent wetting of the high PI materials or if the clays did become wet, the surcharge provided by the overlying soil prevented significant heaving.
